INDIANA DEPARTMENT  
OF ENVIRONMENTAL MANAGEMENT  
SITE INSPECTION FOR  
LUSHER STREET GROUNDWATER  
CONTAMINATION SITE  
ELKHART, INDIANA  
ELKHART COUNTY

SITE INSPECTION REPORT

LUSHER STREET GROUND WATER CONTAMINATION

May 1, 2007

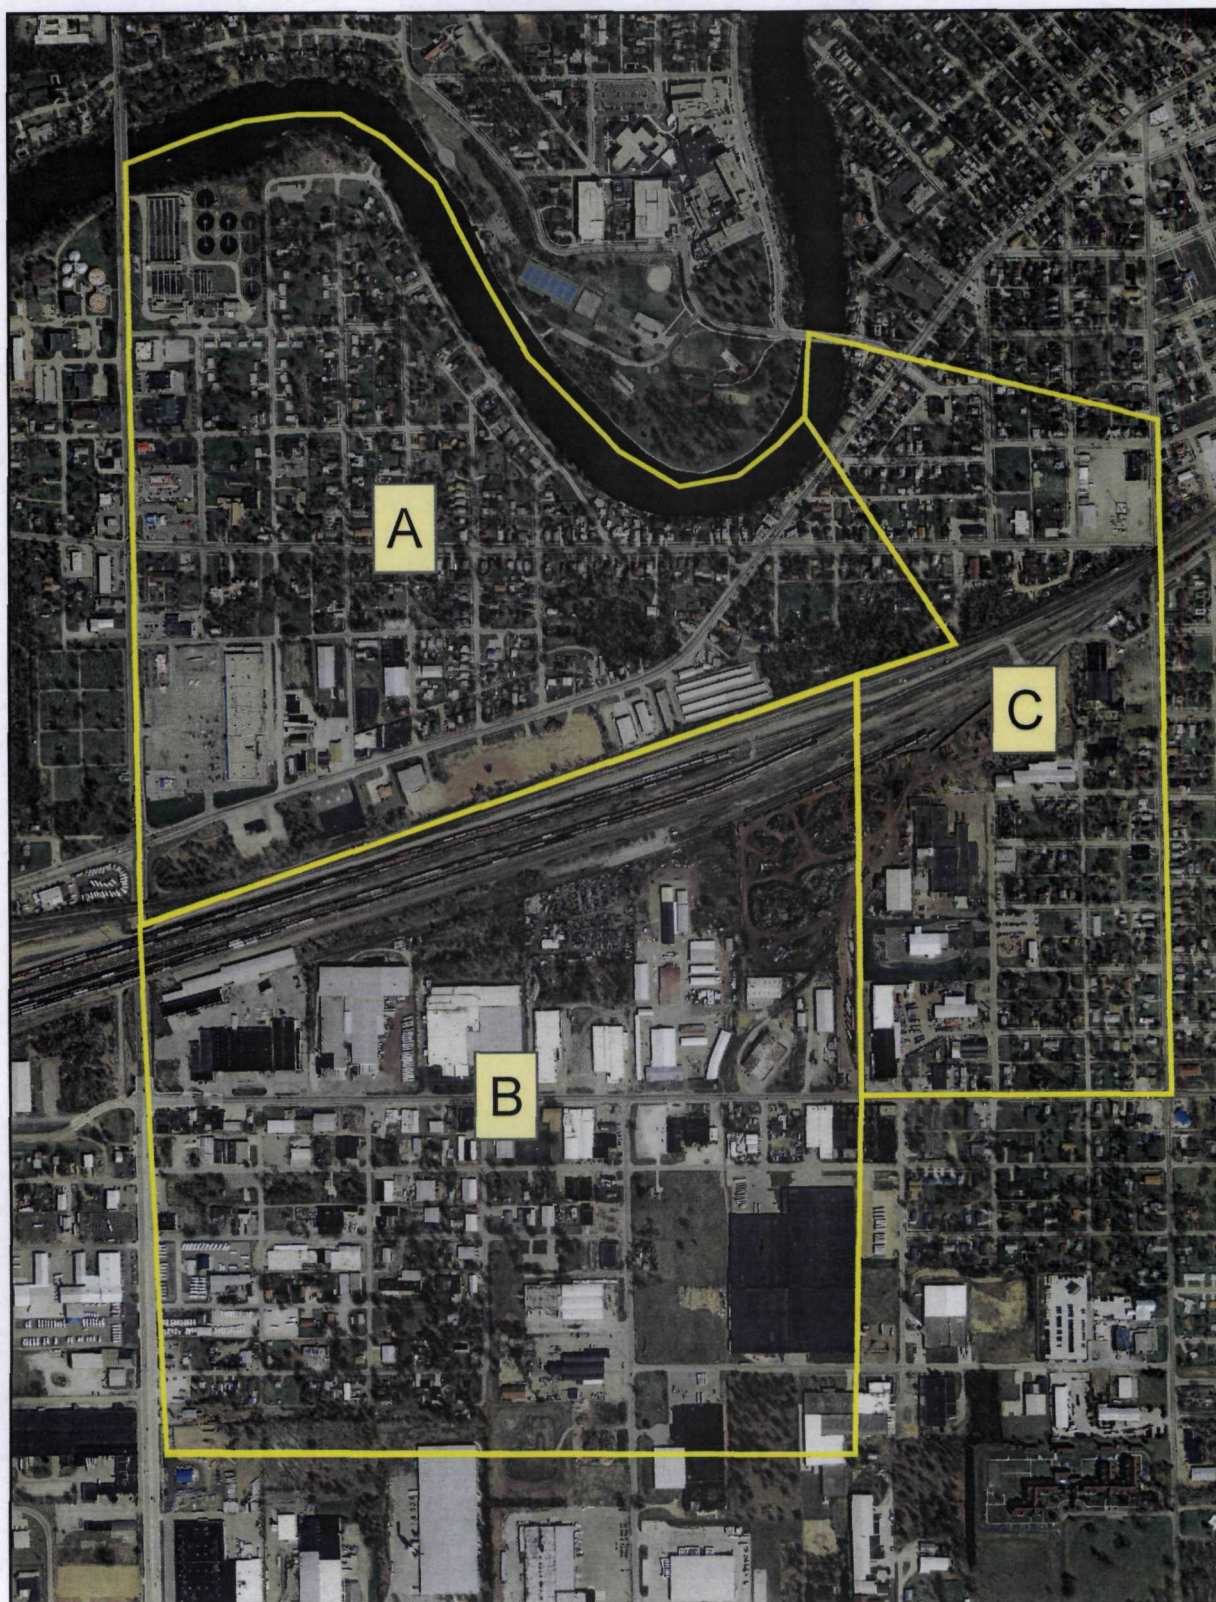
Appendix A  
Lusher Site Map Showing Three Sampling Areas

# Lusher Avenue Site Map Showing Three Sampling Areas, Elkhart County, Elkhart, IN

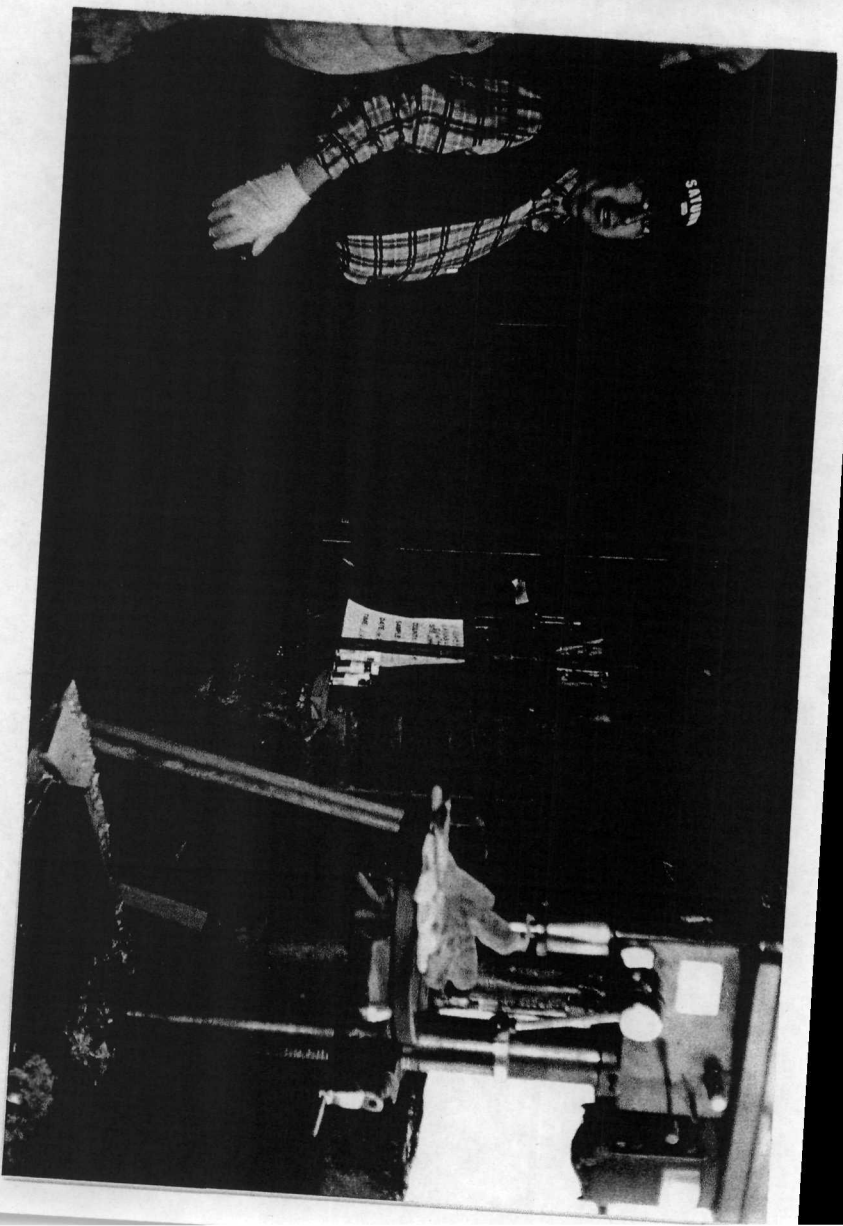
SITE: Lusher Avenue  
EPA ID: IND982073785  
DATE: 12/6/06  
TIME: 1:28 pm  
WEATHER: Cloudy; 20s  
SAMPLE ID # E2P42  
DESCRIPTION: Picture shows  
the area where sample E2P42 was  
obtained

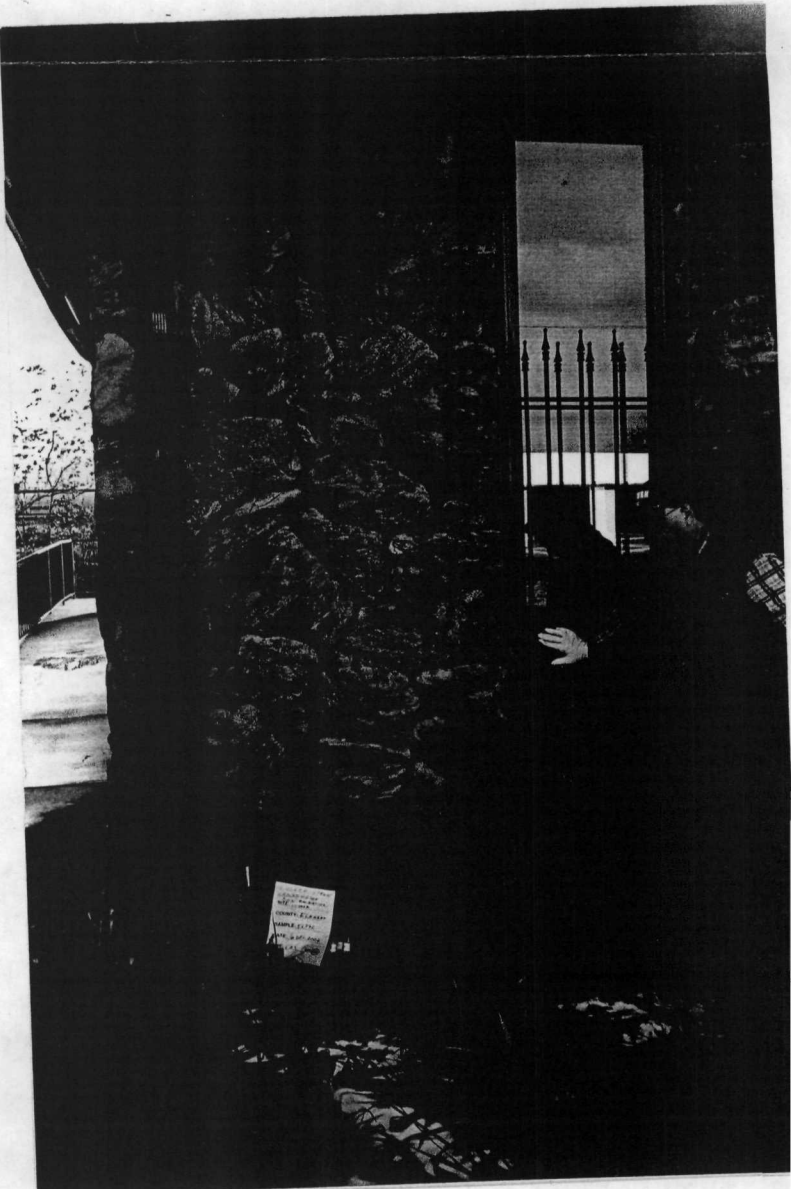
SITE: Lusher Avenue  
EPA ID: IND982073785  
DATE: 12/6/06  
TIME: 1:05 pm  
WEATHER: Cloudy; 20s  
SAMPLE ID # E2P40  
DESCRIPTION: Picture shows  
the area where sample E2P40 was  
obtained

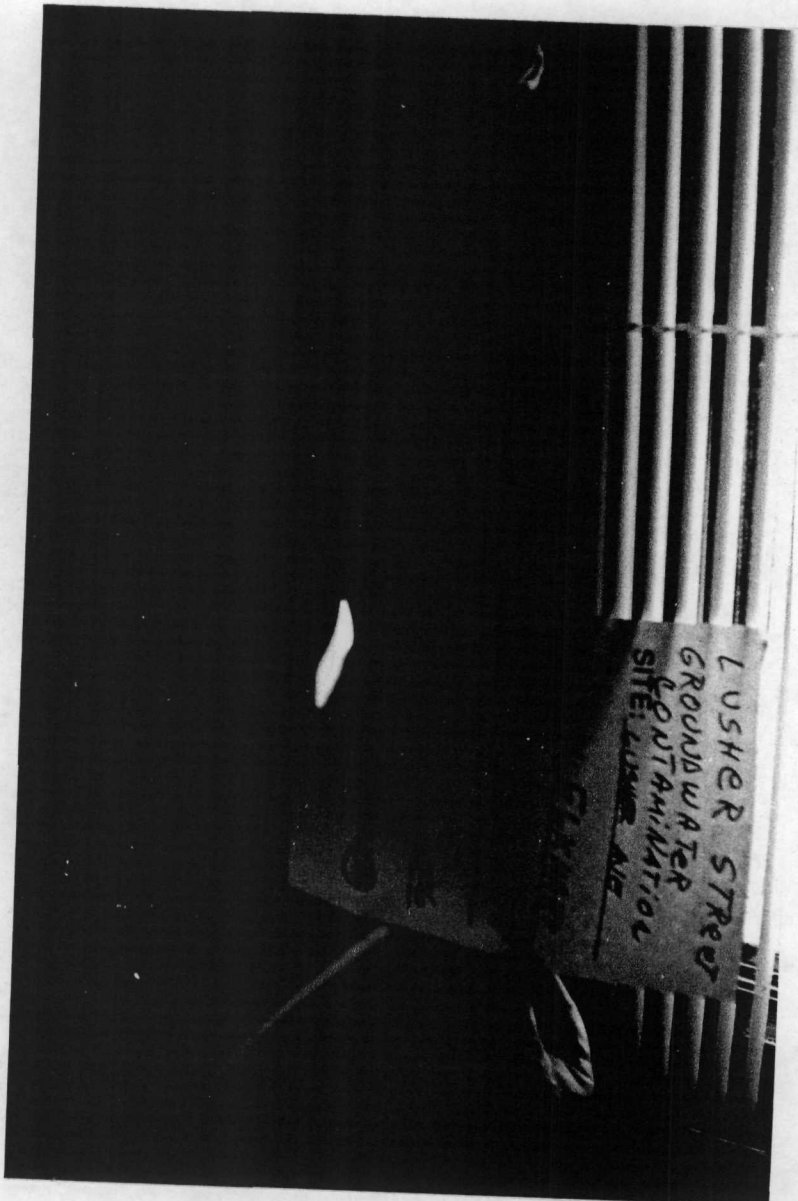
SITE: Lusher Avenue  
EPA ID: IND982073785  
DATE: 12/6/06  
TIME: 12:20 pm  
WEATHER: Cloudy; 20s  
PHOTO BY: Mark Jaworski  
SAMPLE ID: E2P52  
DESCRIPTION: Groundwater  
sample obtained from 1511 Flake

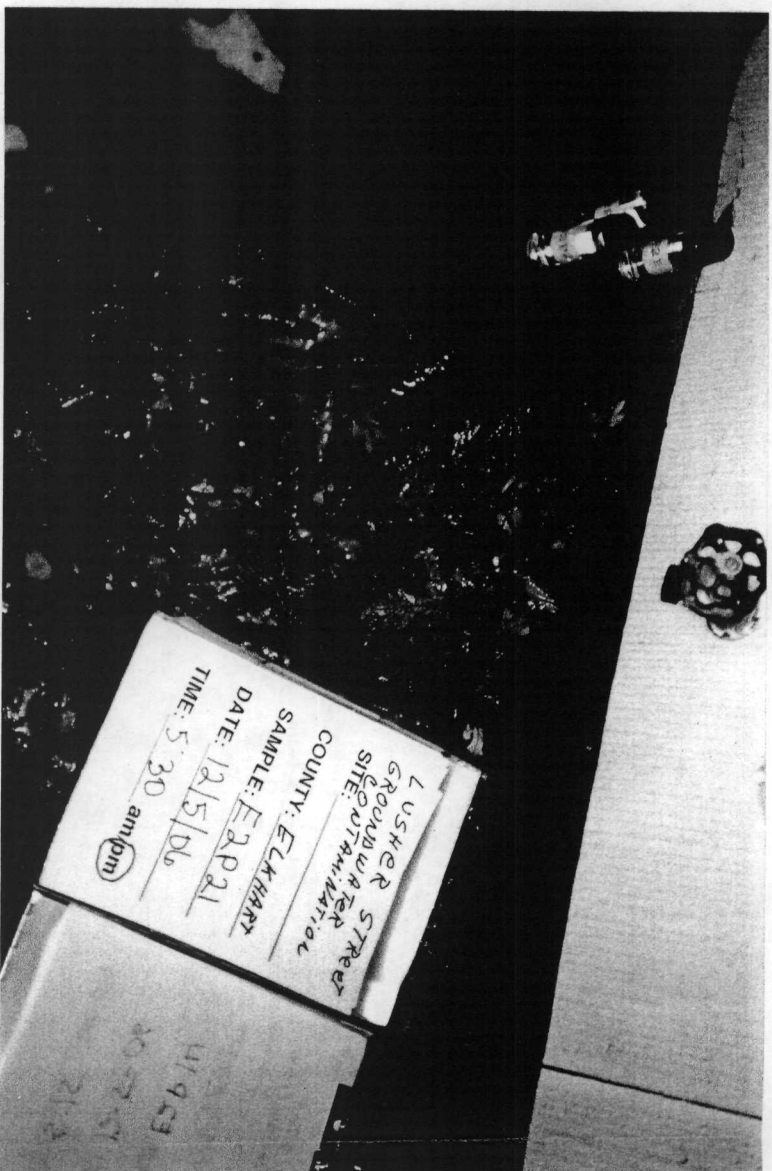
SITE: Lusher Avenue  
EPA ID: IND982073785  
DATE: 12/5/06  
TIME: 5:30 pm  
WEATHER: Cloudy; 20s  
PHOTO BY: Mark Jaworski  
SAMPLE ID: E2P21  
DESCRIPTION: Groundwater  
sample obtained from 1816 Leininger

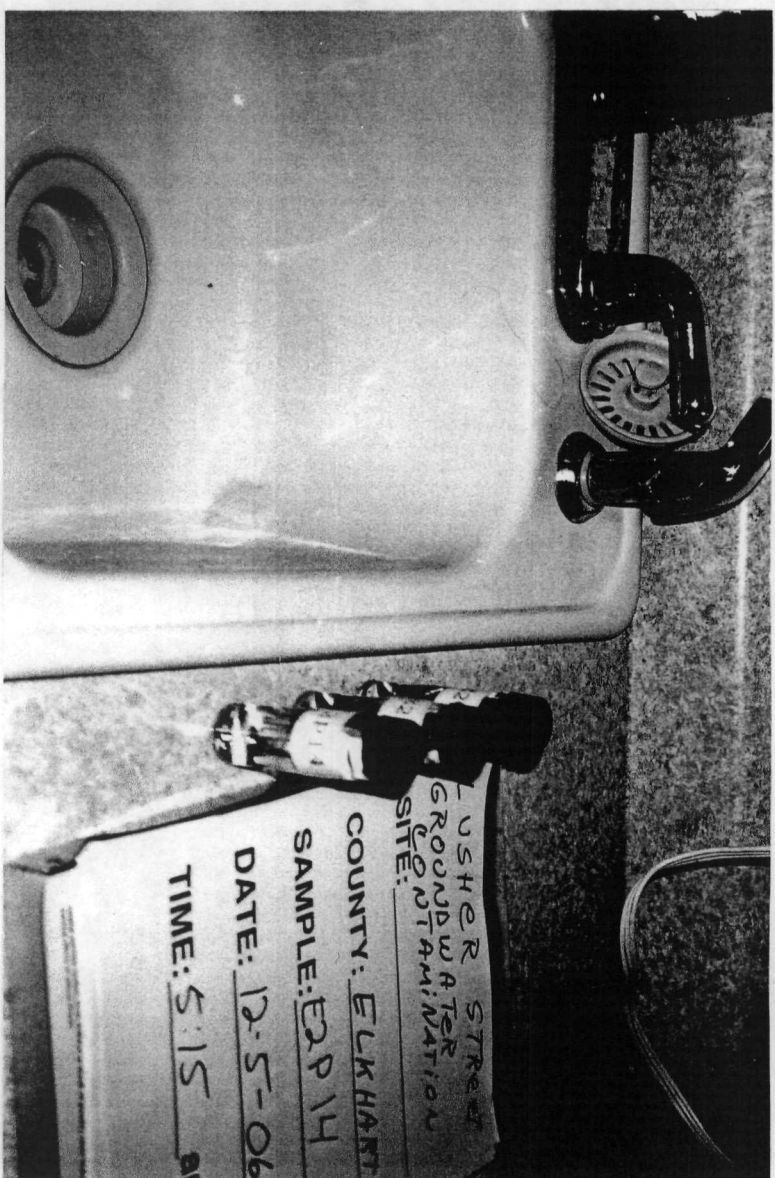
SITE: Lusher Avenue  
EPA ID: IND982073785  
DATE: 12/5/06  
TIME: 5:15 pm  
WEATHER: Cloudy; 20s  
PHOTO BY: Mark Jaworski  
SAMPLE ID: E2P14  
DESCRIPTION: Groundwater  
sample obtained from 1511 Flake

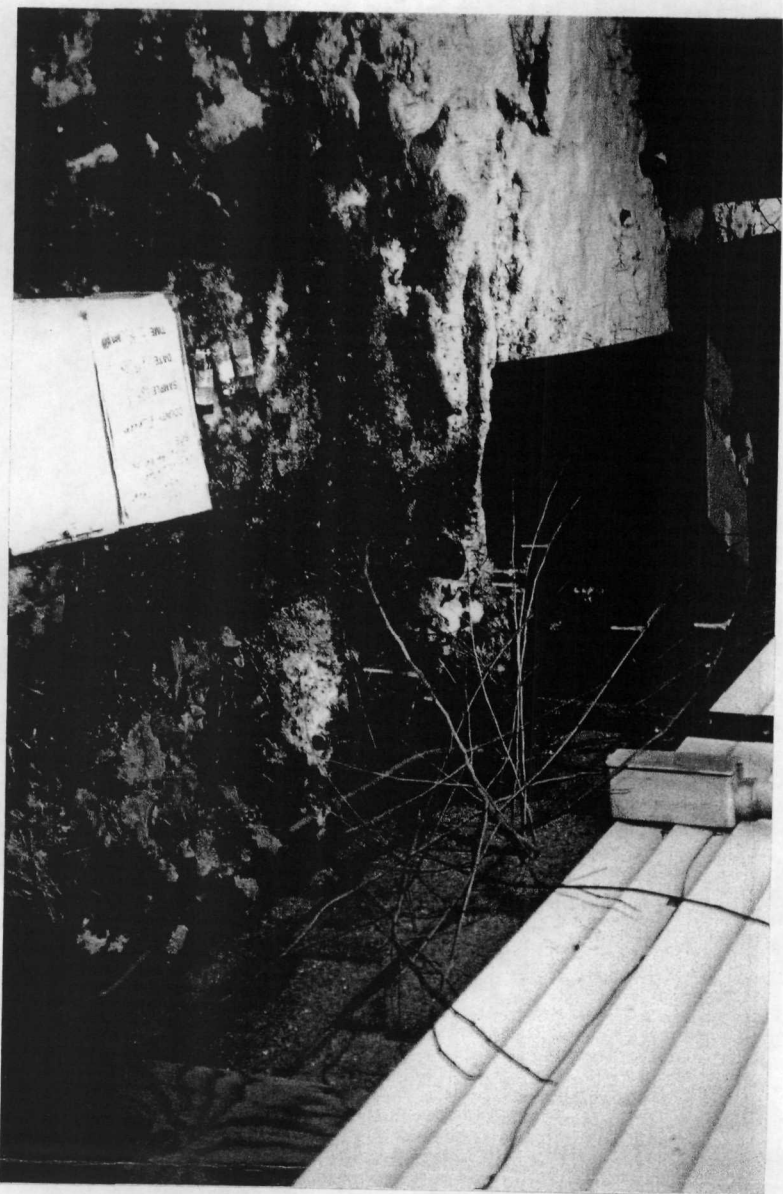
SITE: Lusher Avenue  
EPA ID: IND982073785  
DATE: 12/6/06  
TIME: 4:30 pm  
WEATHER: Cloudy; 20s  
SAMPLE ID # E2P18  
DESCRIPTION: Picture  
shows the area where sample  
E2P18 was obtained

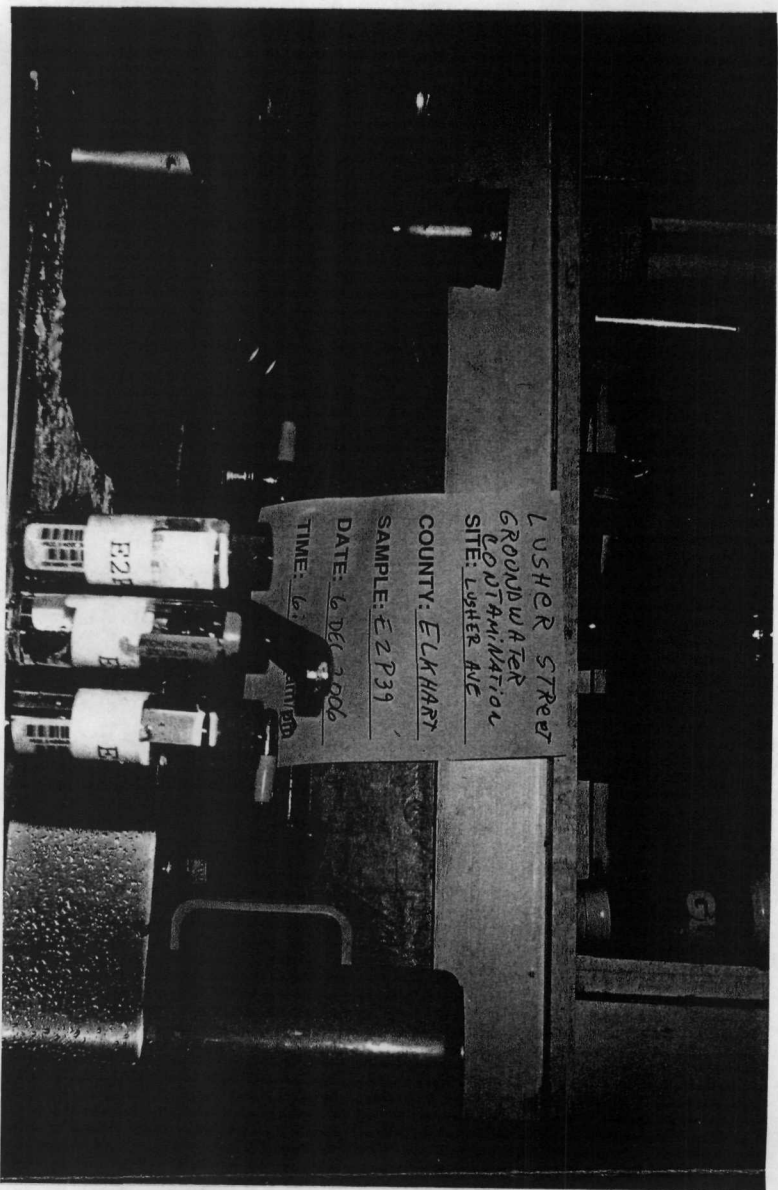
SITE: Lusher Avenue  
EPA ID: IND982073785  
DATE: 12/6/06  
TIME: 6:15 pm  
WEATHER: Cloudy; 20s  
PHOTO BY: Mark Jaworski  
SAMPLE ID: E2P39  
DESCRIPTION: Groundwater  
sample obtained from 1510 Flake

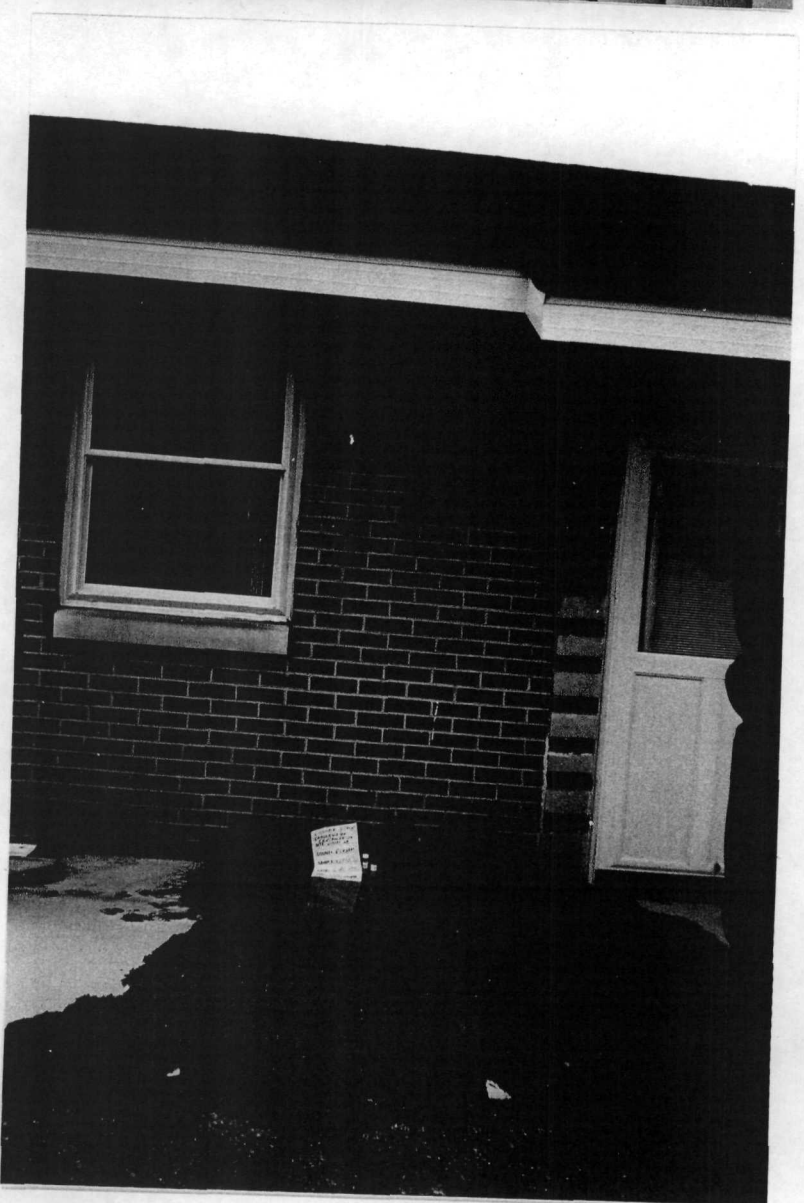
SITE: Lusher Avenue  
EPA ID: IND982073785  
DATE: 12/6/06  
TIME: 4:20 pm  
WEATHER: Cloudy; 20s  
SAMPLE ID # E2P43  
DESCRIPTION: Picture  
shows the area where sample  
E2P43 was obtained

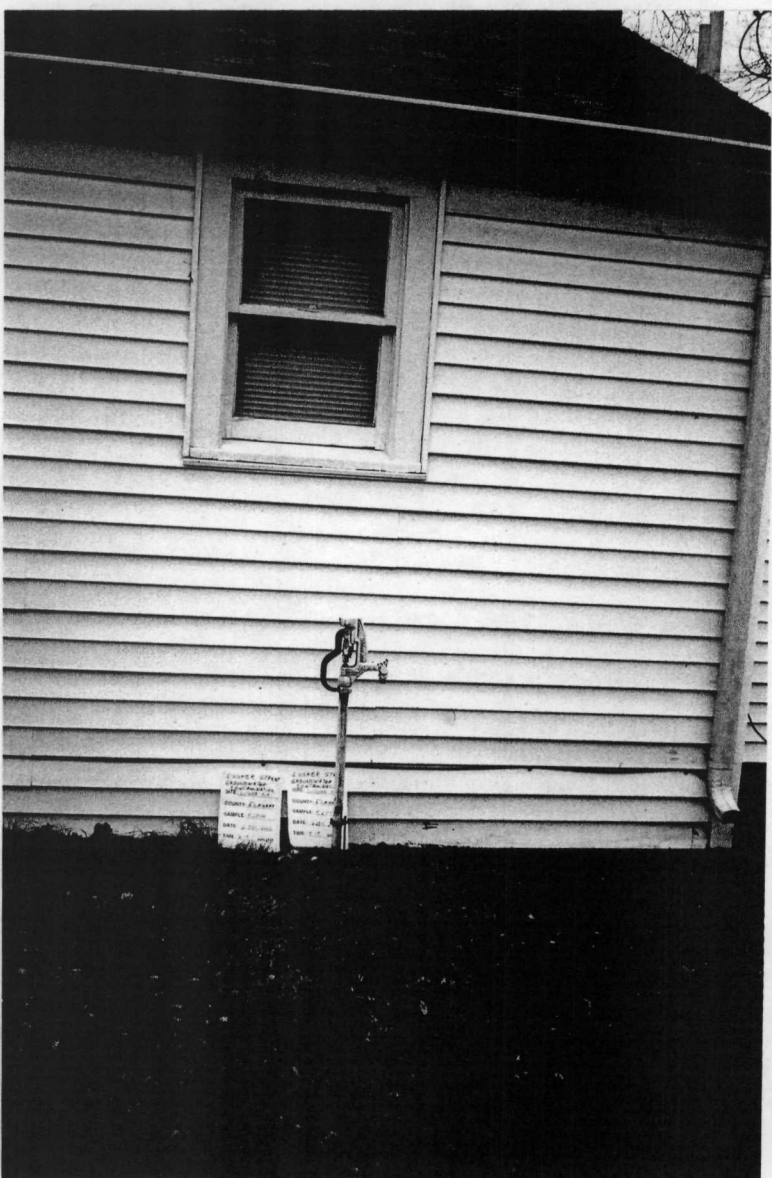
SITE: Lusher Avenue  
EPA ID: IND982073785  
DATE: 12/6/06  
TIME: 4:15 pm  
WEATHER: Cloudy; 20s  
SAMPLE ID # E2P44 & E2P51  
DESCRIPTION: Picture  
shows the area where sample  
E2P44 and E2P51 were  
obtained

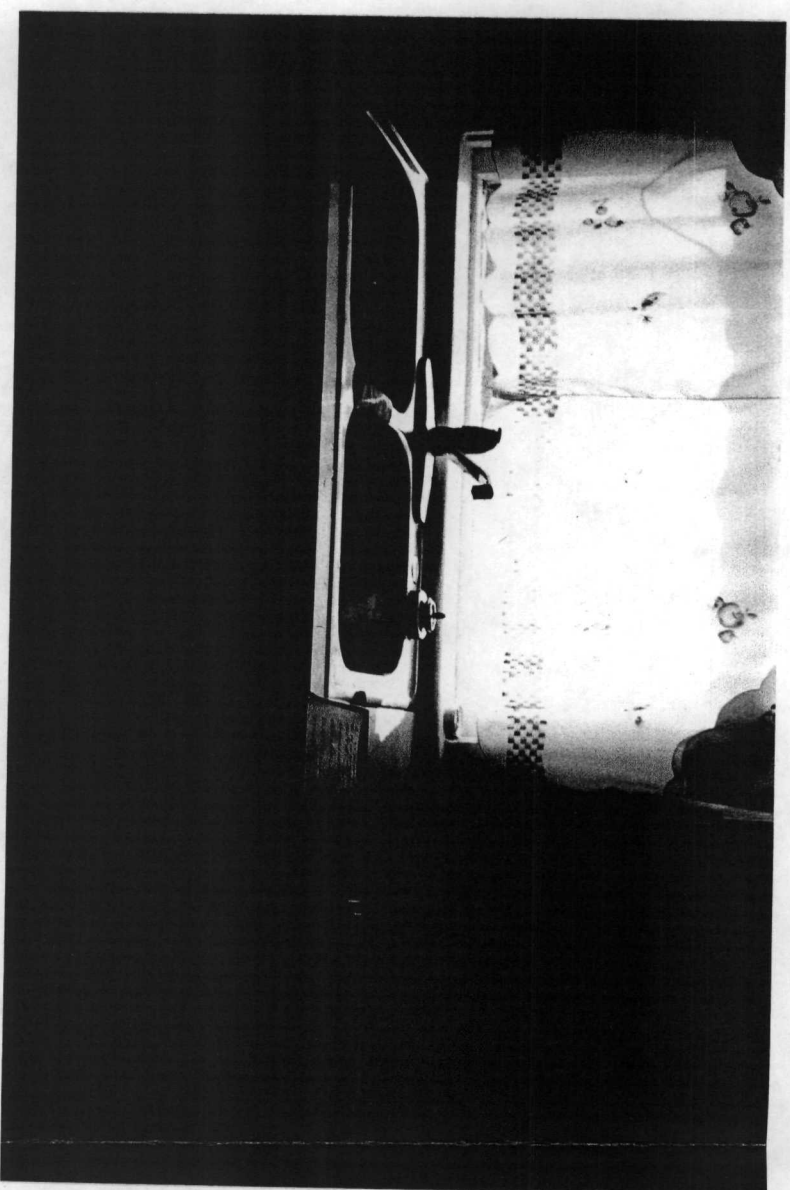
SITE: Lusher Avenue  
EPA ID: IND982073785  
DATE: 12/6/06  
TIME: 11:30 pm  
WEATHER: Cloudy, 20s  
SAMPLE ID # E2P17  
DESCRIPTION: Picture  
shows the area where samples  
E2P17 & E2P10 were obtained

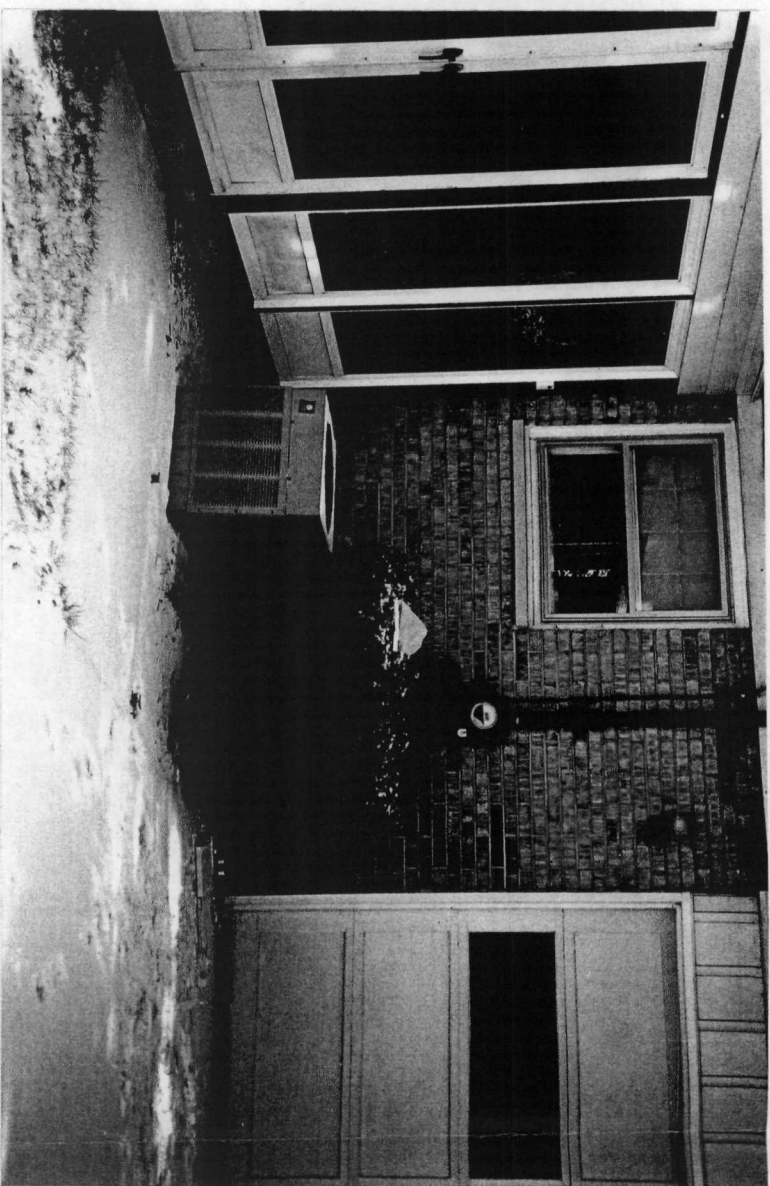
SITE: Lusher Avenue  
EPA ID: IND982073785  
DATE: 12/5/06  
TIME: 12:25 pm  
WEATHER: Cloudy; 20s  
SAMPLE ID # E2P15  
DESCRIPTION: Picture  
shows the area where sample  
E2P15 was obtained

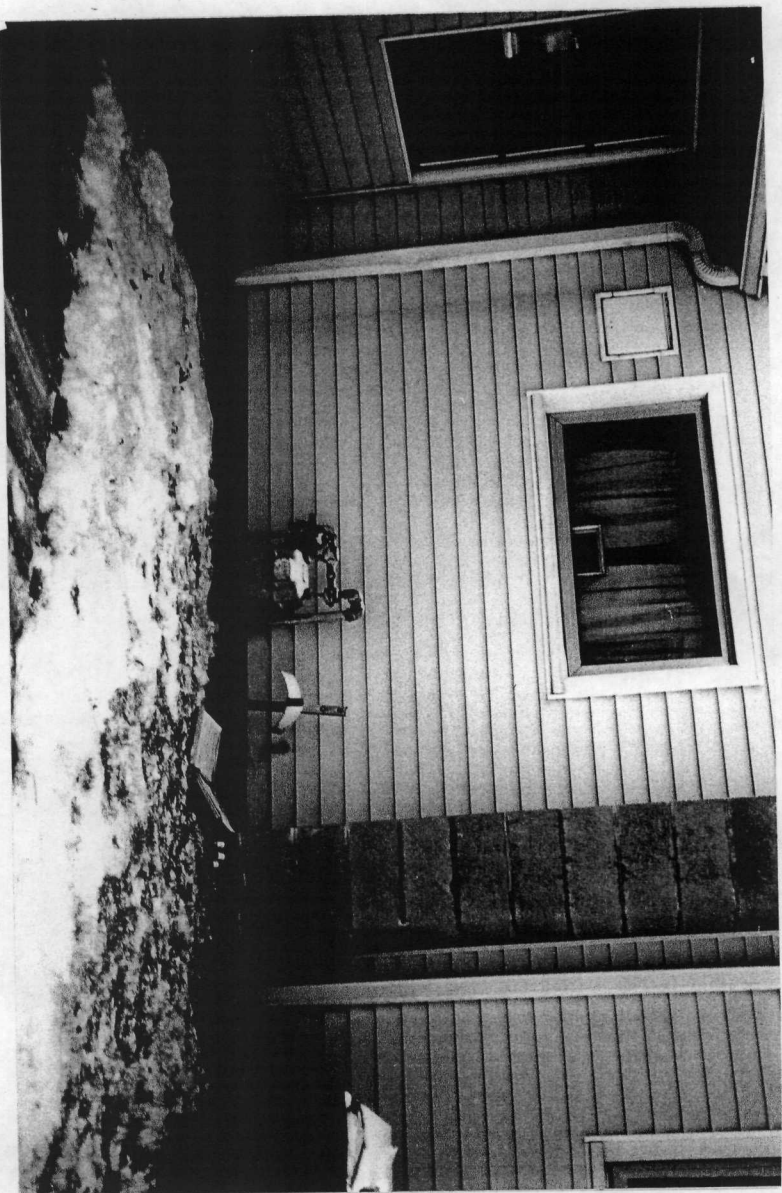
SITE: Lusher Avenue  
EPA ID: IND982073785  
DATE: 12/6/06  
TIME: 1:00 pm  
WEATHER: Cloudy; 20s  
SAMPLE ID # E2P11  
DESCRIPTION: Picture  
shows the area where sample  
E2P11 was obtained

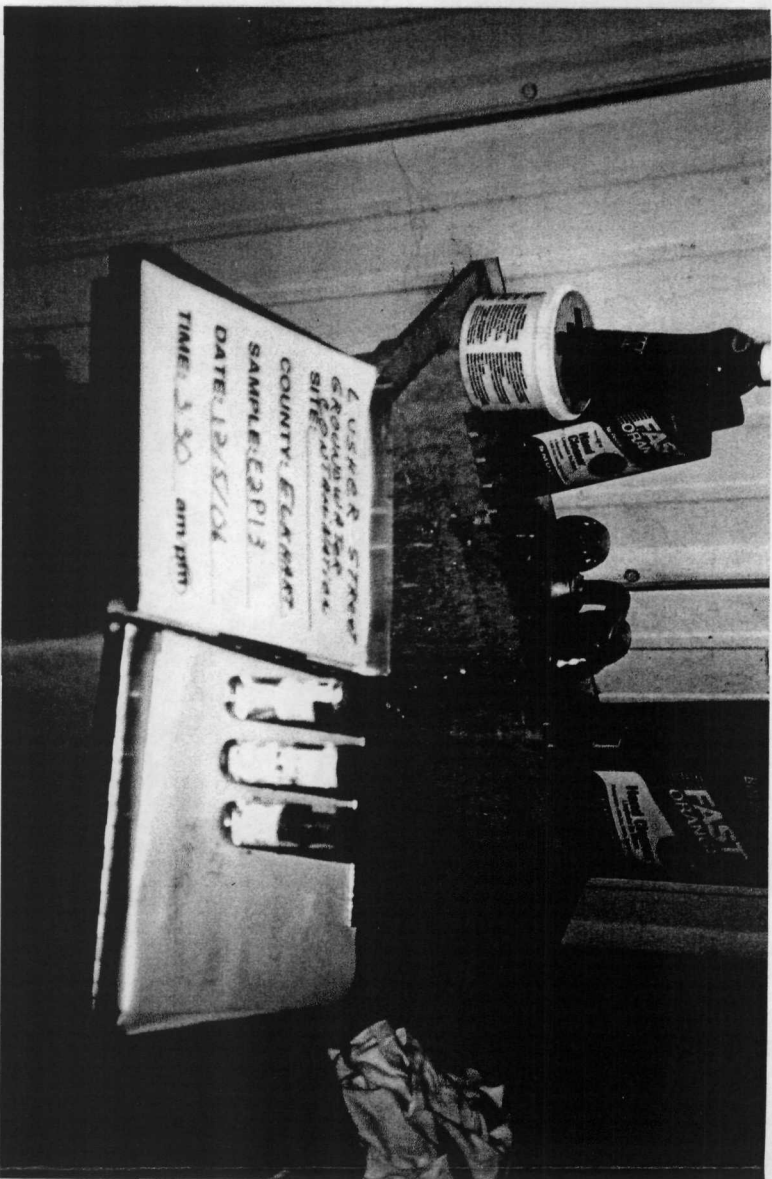
SITE: Lusher Avenue  
EPA ID: IND982073785  
DATE: 12/5/06  
TIME: 3:30 pm  
WEATHER: Cloudy; 20s  
PHOTO BY: Mark Jaworski  
SAMPLE ID: E2P13  
DESCRIPTION: Groundwater  
sample obtained from 1800  
Markle Street

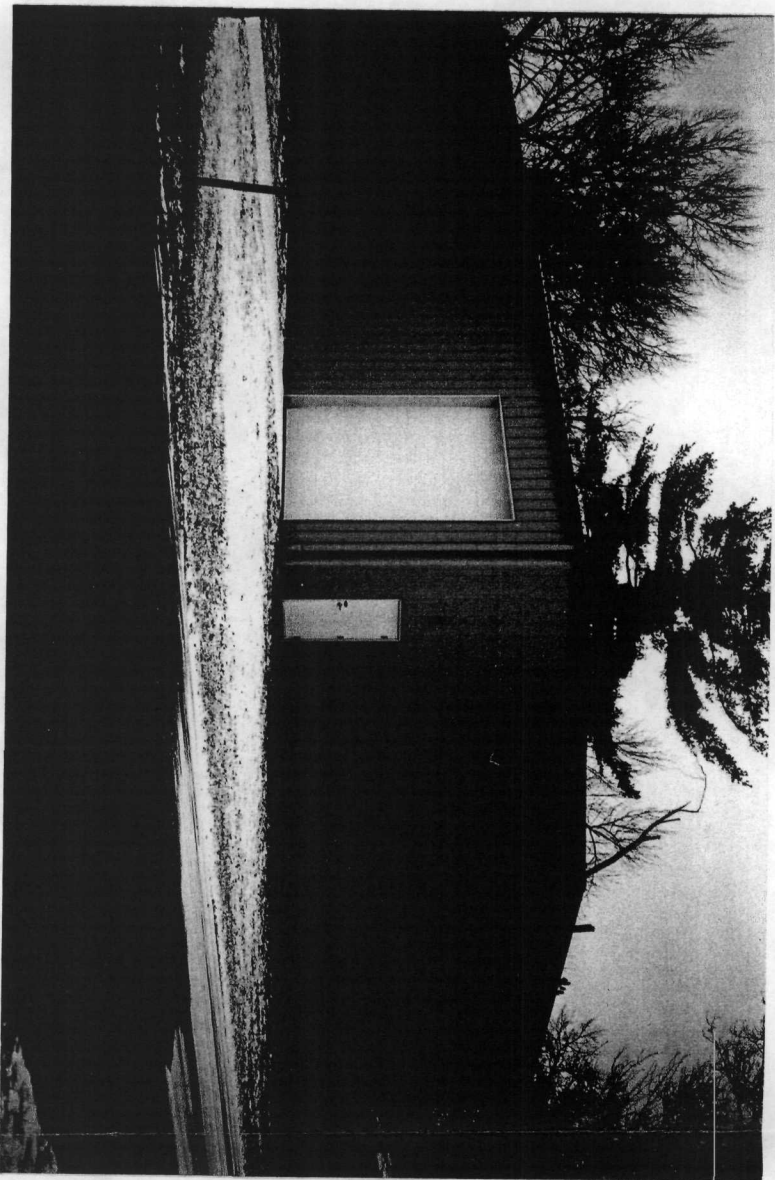
SITE: Lusher Avenue  
EPA ID: IND982073785  
DATE: 12/5/06  
TIME: 3:45 pm  
WEATHER: Cloudy; 20s  
SAMPLE ID # E2P58  
DESCRIPTION: Picture  
shows the area where sample  
E2P58 was obtained

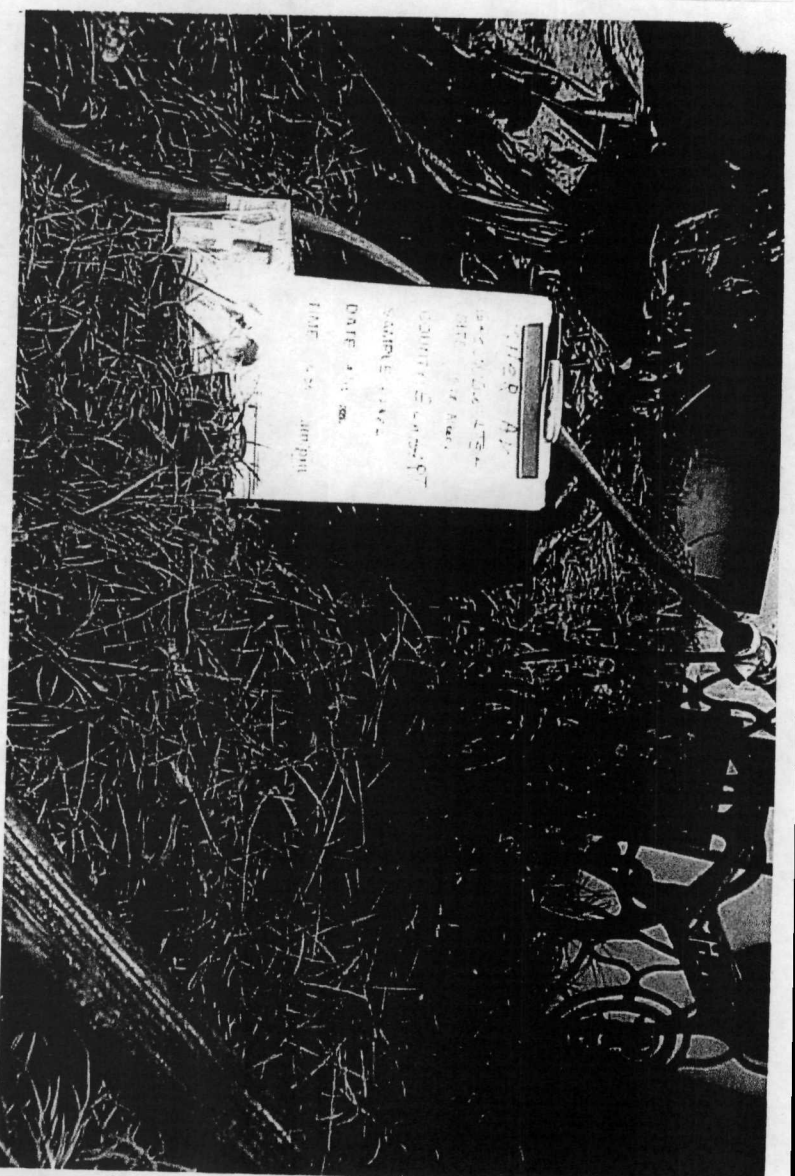
SITE: Lusher Avenue  
EPA ID: IND982073785  
DATE: 9/12/06  
TIME: 5:30 pm  
WEATHER: Cloudy; 70s  
SAMPLE ID # E2NZ2  
DESCRIPTION: Duplicate of E2NX4  
Groundwater sample obtained from  
1520 Albany

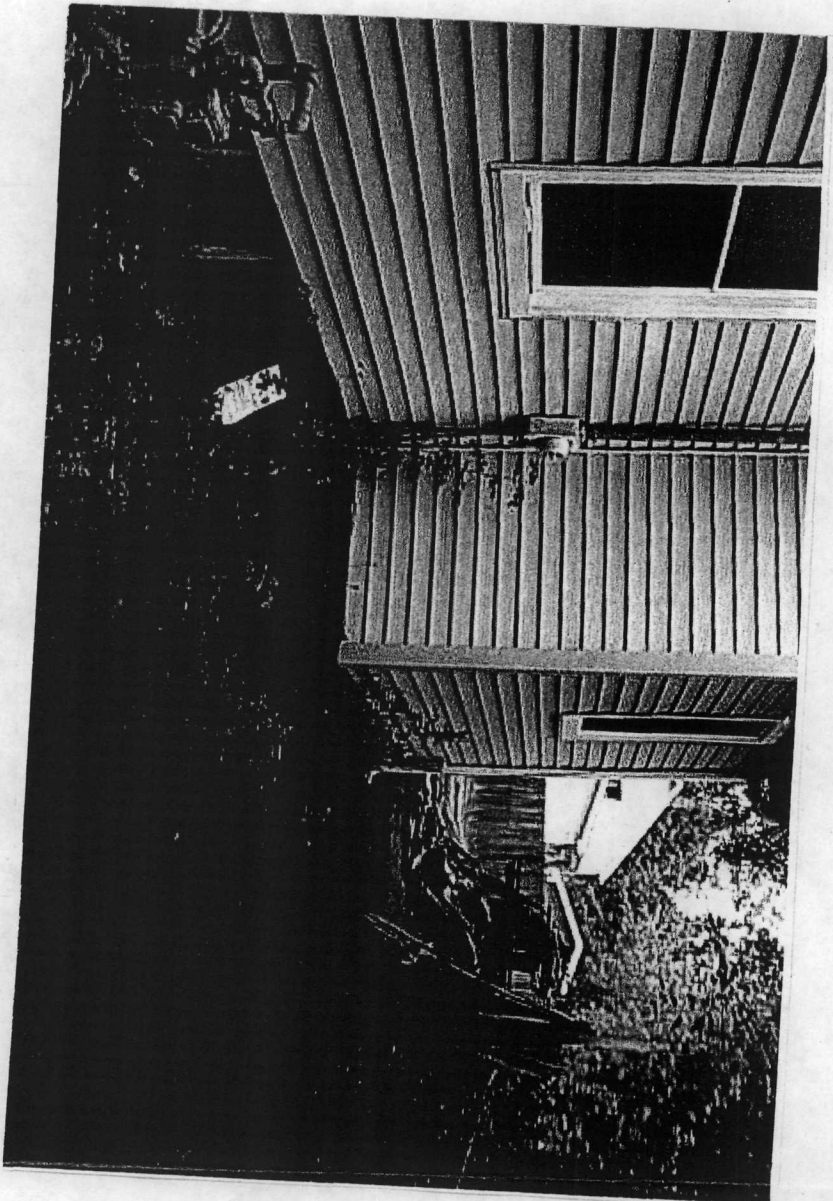
SITE: Lusher Avenue  
EPA ID: IND982073785  
DATE: 9/12/06  
TIME: 12:20 pm  
WEATHER: Cloudy; 70s  
PHOTO BY: Mark Jaworski  
SAMPLE ID: E2NY6  
DESCRIPTION: Picture shows the  
area where groundwater sample  
E2NY6 was obtained

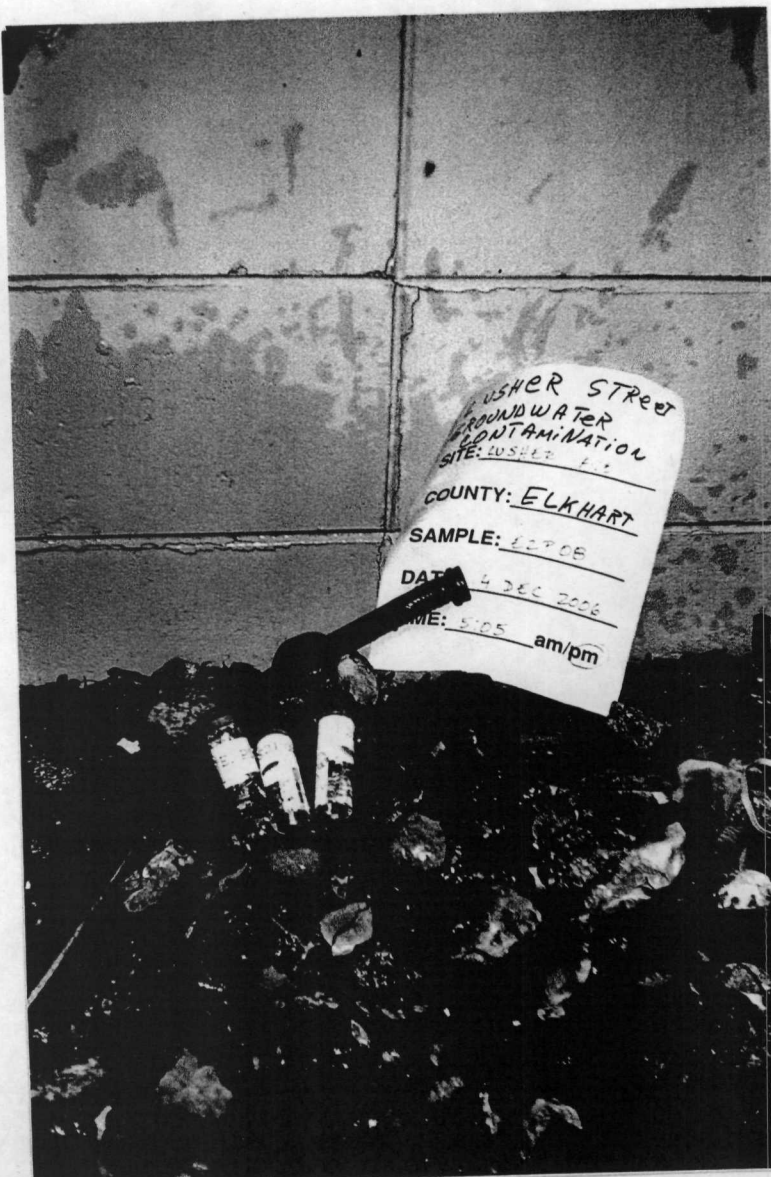
SITE: Lusher Street Groundwater  
Contamination Site  
EPA ID: IND982073785  
DATE: 12/5/06  
TIME: 5:05 pm  
WEATHER: Cloudy; 20s  
SAMPLE ID: E2P08  
DESCRIPTION: Groundwater sample  
obtained from 1840 Borneman
